# UP IN THE AIR

## Alleviating drainage well geysering in Florida

By Deodat Budhu & Maricela Torres

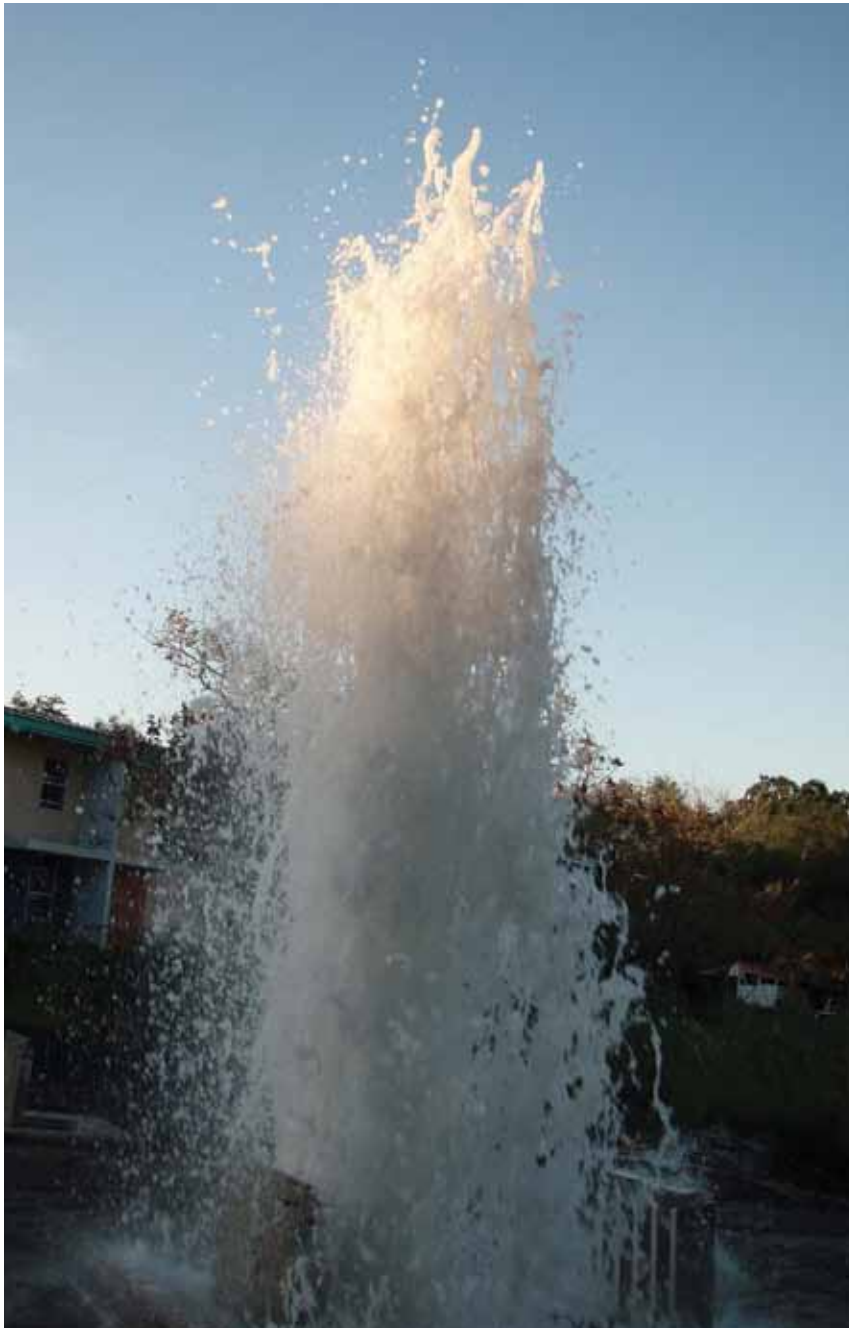
Geysering drainage wells are of particular concern because they usually are in urban settings where the violent discharge of water can become a threat to public health, safety and welfare.

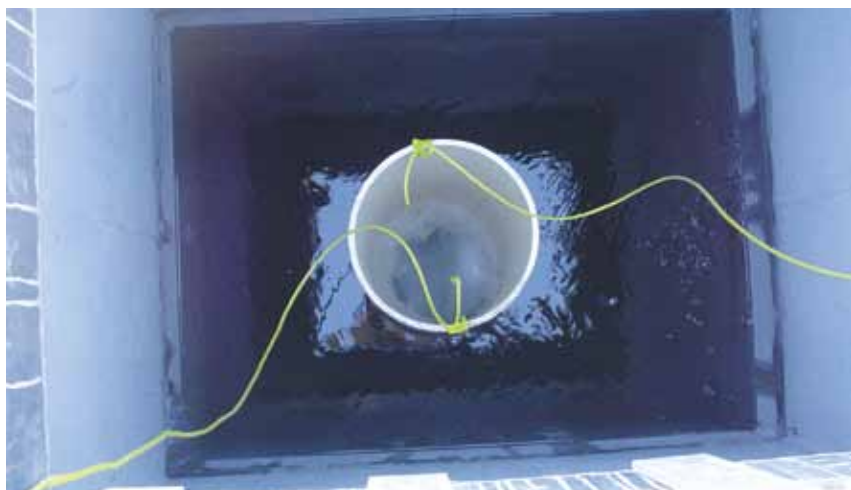
The Lake Holden well coupling helped reduce water discharge and minimize the amount of air being sucked down into the well.

Because the key to preventing geysering is to stop or minimize the formation of trapped air within the well column or in cavities within the aquifer, one successful approach in past Orange County projects has been to install a notched coupling at the top of the well casing to reduce the discharge and minimize the amount of air being sucked down into the well. The coupling is notched over part of the perimeter and acts as a weir. Flow only enters the well through the notched portion of the coupling, and its size can be adjusted based on actual trials. This measure successfully eliminated geysering at drainage wells in Lake Holden and Keystone Drive, both located in Orlando, Fla., and allowed acceptable levels of discharge.

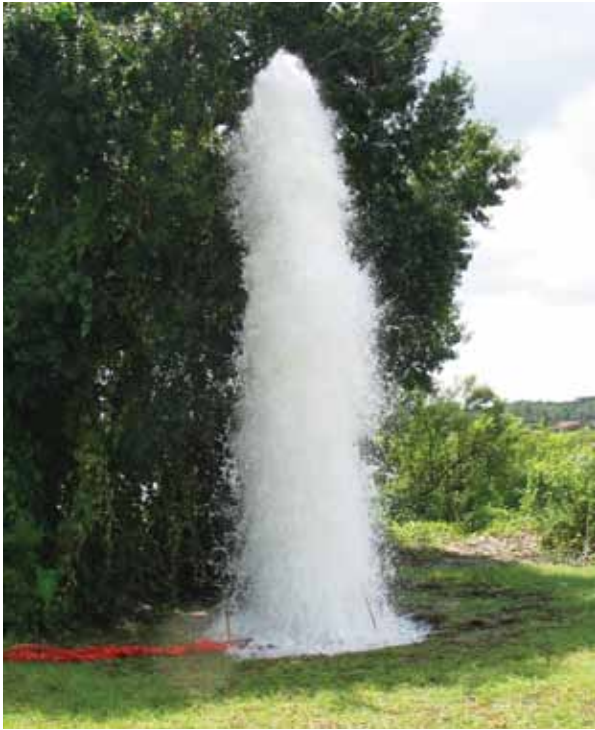
The Keystone Drive well was replaced with one 12-in.-diameter, 303-ft-deep well, but several days after completion, the well was observed to geyser.

The existing Keystone Drive drainage well was replaced with one 12-in.-diameter, 303-ft-deep well. Several days after completion, the well was observed to geyser. In an effort to address the geysering, approval from the permitting agencies was obtained to extend the open borehole to 400 ft. Geysering still occurred, however. In order to eliminate it, a section of PVC pipe with a rectangular orifice was fitted to the top of the well casing to limit the flow entering the wellhead and prevent air entrapment within the formation. Seven years have passed since the installation of the weir coupling, and no geysering has been observed.
