Urban Stream MANAGEMENT

Variety of stabilization practices save an eroding Illinois tributary

By Jonathan Koepke, CPESC, LEED AP

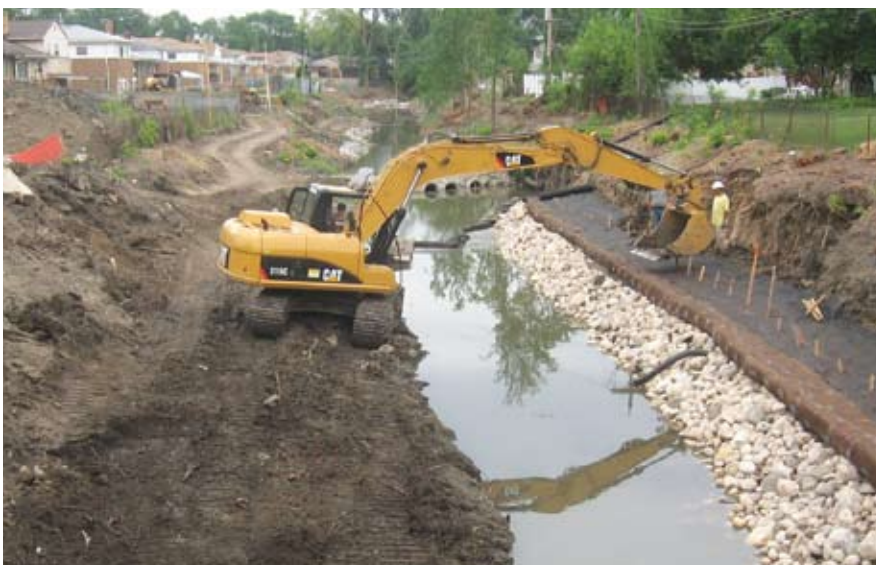
The Silver Creek Phase III project comprised many streambank stabilization solutions, including soil lifts.

The most critical portion of the project was just downstream of a major bridge crossing on an outside meander of the creek. A nearly vertical eroded bank had been created about 6 ft in height. In order to restore this portion of creek bank, a series of soil lifts was reconstructed in this 200-ft section of bank utilizing uniaxial geogrid reinforcement of the backfill material used to reconstruct

the slope. In addition, a geogrid soil lift was constructed just above the rock toe stabilization utilizing a 3-D combination of erosion control and turf reinforcement matting. The face of the soil lift and the remaining slope were seeded with a specialized native seed mixture specific to this project. The upper portions of the slope and the regarded slopes were then seeded and stabilized using a bionet straw coconut erosion blanket.

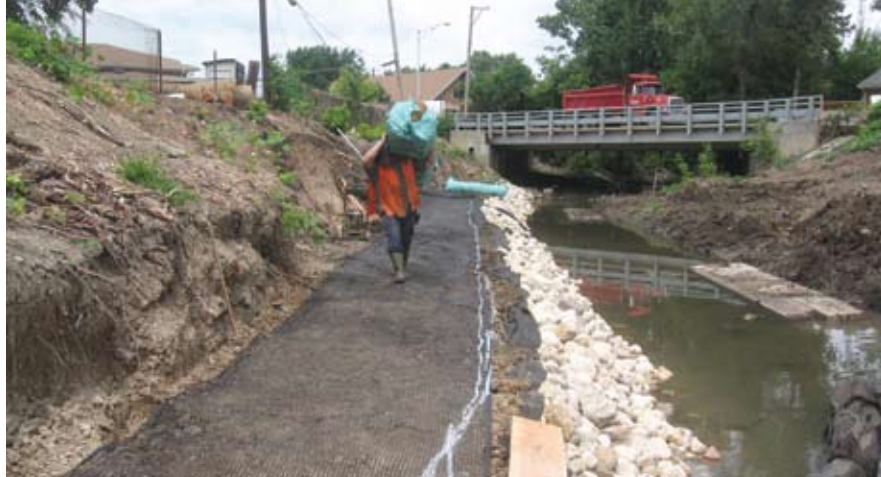
Workers installed geogrids on select stretches of Silver Creek.

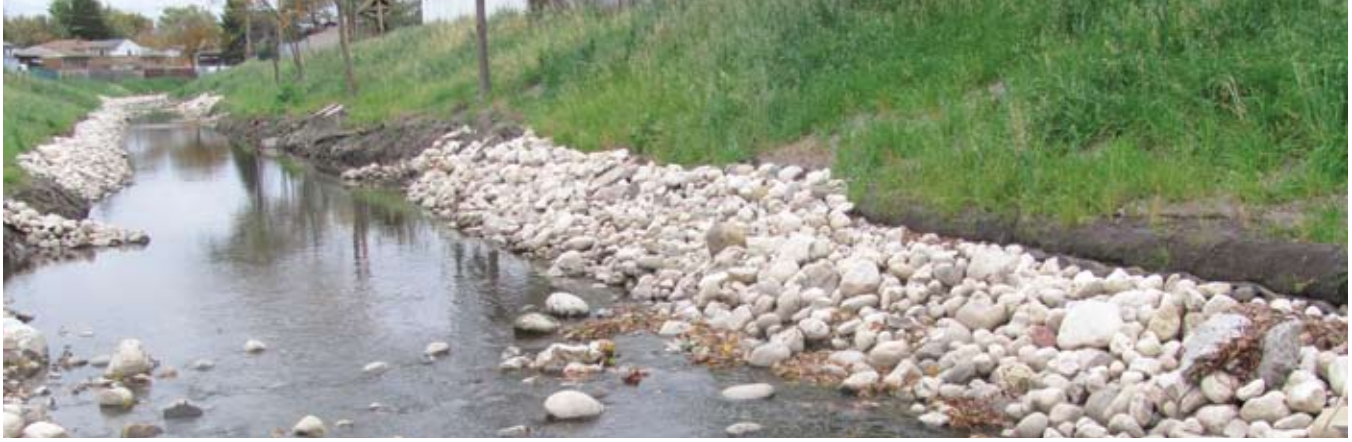
The streambank solutions have withstood heavy rainfall while meeting project goals.

Within 24 hours of construction of this critical section of the project area, a severe thunderstorm dropped nearly 6 in. of rain on it within a few hours. The result caused flood depths of nearly 8 ft above base flow, with massive flooding of the work area. To the satisfaction of the contractor, engineer and village, the project withstood the flooding with no damage, at a time when it was at its weakest. This was truly a testament to the power of design and proper construction.
