Traffic

NEVER STOPPED

Florida DOT builds new box culvert from within

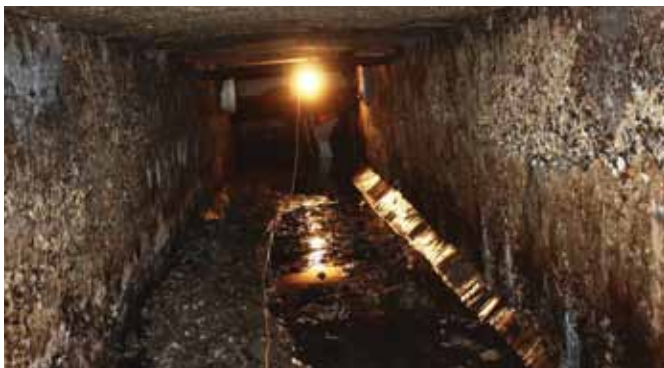
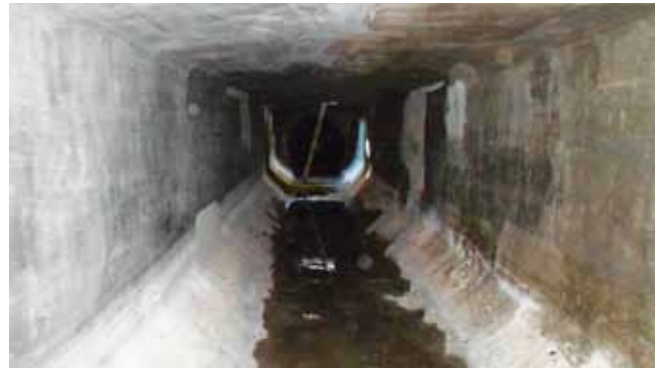
Left: The box culvert under State Road 64 before rehabilitation was believed to be almost a century old and was structurally unsound. Right: After rehabilitation, there are no signs of shrinkage, and the culvert appears watertight.

With the culvert substrate cleaned and stabilized, the TVD team then built a metal reinforcement cage out of welded Grade 60 mesh that could be worked with hand tools. This allowed snug fitting of the mesh around utilities, storm water lines and other culvert breaches within the existing walls. Depth gauges were anchored to the substrate to verify the minimum 5-in. thickness specified for the new culvert walls. Multiple layers were applied along with hand troweling to ensure that material would be worked into the tight spots. Grout test cube samplings were collected daily for quality assurance, along with regular visual inspection of the depth gauges. Seven days after project completion, the cube testing already exceeded the 7,000 PSI anticipated lab results, while down below ground, all appears to be well still: No signs of shrinkage are visible, and the culvert remains smooth and watertight.
