Soil Erosion in the Panama Canal

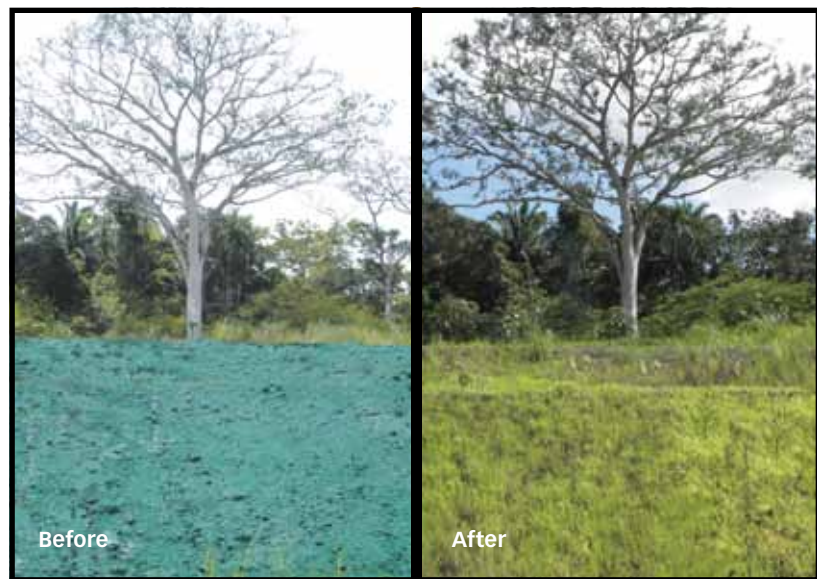
The matrix had very little (less than two hours) drying time before it started to rain. During the weeks following the applications, several heavy rainfalls hit Panama. Despite the intense precipitation and short drying time, X9000 was able to hold the soil, seed and fertilizer in place to ensure successful germination. The righthand photo shows the area approximately five weeks after X9000 was applied.

Hamilton Mfg. Inc. got wind of the project that was underway in Panama and set out to put its product to the test. NaturesOwn X9000 is a bonded fiber matrix hydro-mulch that is designed and manufactured to excel in erosion control in the toughest of climates and environmental conditions. In this particular case, X9000 was applied in the jungles of Panama during the rainy season to slopes of 3:1 to 2:1. The coverage was 4,000 lb per

acre, and it was sprayed in a two-step process for the most effective coverage.
