# All the Way to the Bank

## Stream restoration as a way to combat erosion

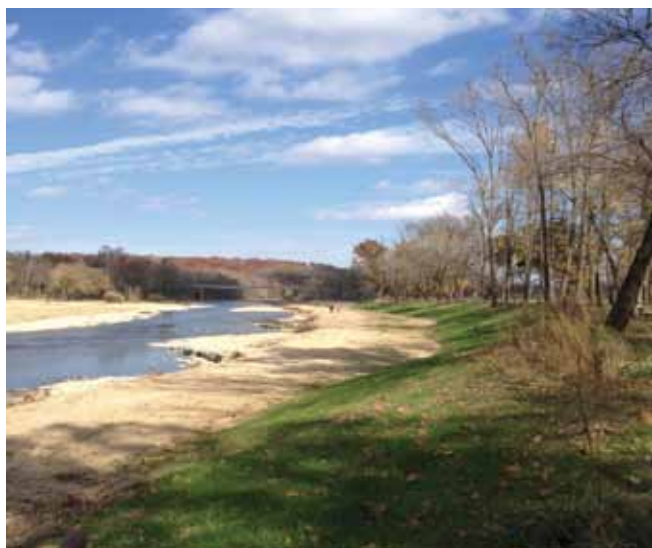
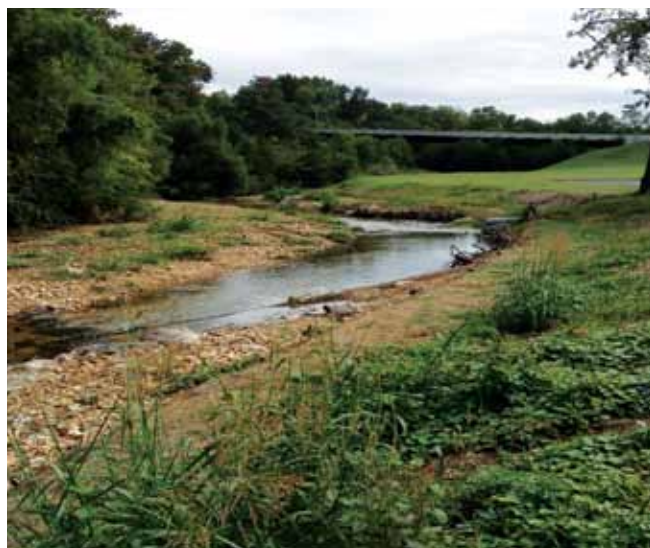
To address bank erosion, the Oklahoma Conservation Commission and Oklahoma State University undertook a project to restore more than 6,500 ft of streambank, reducing the amount of sediment in the system by more than 900 tons per year.

To repair the streams, the designer used bioengineering techniques, which included installing rock vanes, J-hooks and other instream structures, in conjunction with channel realignment, bank resloping and reestablishing vegetation in the riparian area. These methods of stream restoration have not been widely used in Oklahoma; therefore, educating people about the methods was an important part of the project. The intent was that by educating the public, decision-makers, local engineers and contractors about the benefits of natural stream restoration as a way to reduce erosion, more stream restoration will be done in the watershed and throughout the state.

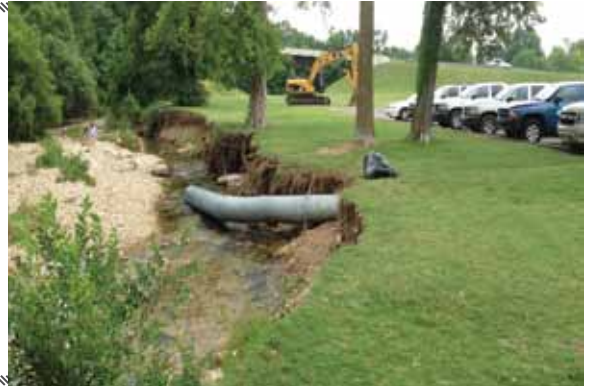
One of the sites located in a public park, pre-construction, in June 2012.

Each site had significant bank erosion and was impacting or threatening infrastructure like roads, sewer lines and trails. Several of the sites had vertical banks of up to 15 ft, minimal vegetation and little floodplain connectivity. At two
