# AFTER THE STORM

A new approach to heavy storm management

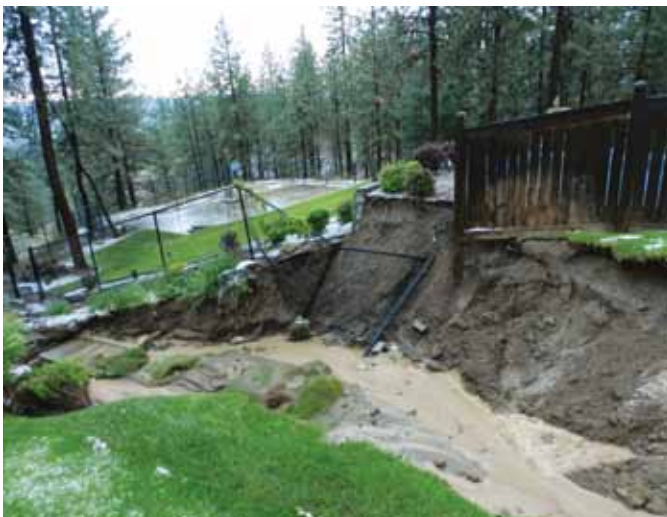
At that point, the storm water jumped the weir and forcefully eroded the slope below, creating a 15-ft-wide, 10-ft-deep gully. Homeowners lost their backyard fences and some landscaping. One homeowner nearly lost his swimming pool. Debris and sloughed soil then traveled at least a quarter mile before slowing at flatter elevations.

Left: After a flood during an early summer storm in 2011, residents of Spokane incurred damage to their fencing and erosion of their backyards. Right: The construction crew of Spokane's Wastewater Department decided to extend the swale and build cascading steps to control future floods.

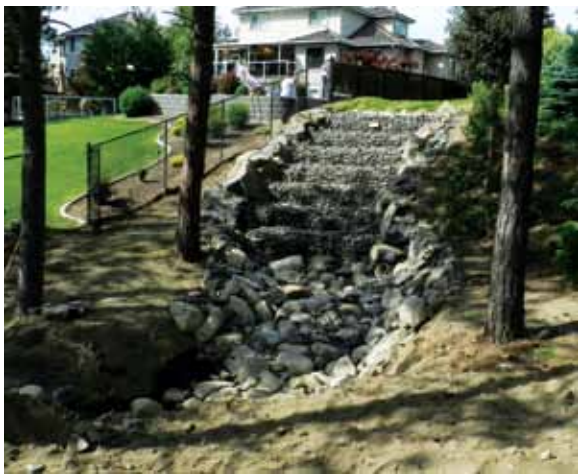
The finished project was both functional and attractive, and became known throughout the neighborhood as Weile Falls.

After cleaning out the channel and removing excess sediment, individual rocks were placed to guide the water from the gabion steps around the trees and down the valley. Culverts were added for the hiking and biking trail that traversed the river bed, and everything was raked out smoothly.

In March of 2012, another intense storm hit Spokane. Afterward, Weile Falls was assessed, and no damage or erosion was found. The storm water had filled the extended swale and overflowed into the cascading falls. It appeared that the storm water had soaked through the first rock gabion on the falls, helping dissipate flow rate and volume. Given the magnitude of this most recent storm, it appears that Weile Falls will be a durable, long-lasting solution.
