OFF THE WALL

Wisconsin residential bluff is stabilized with a living wall

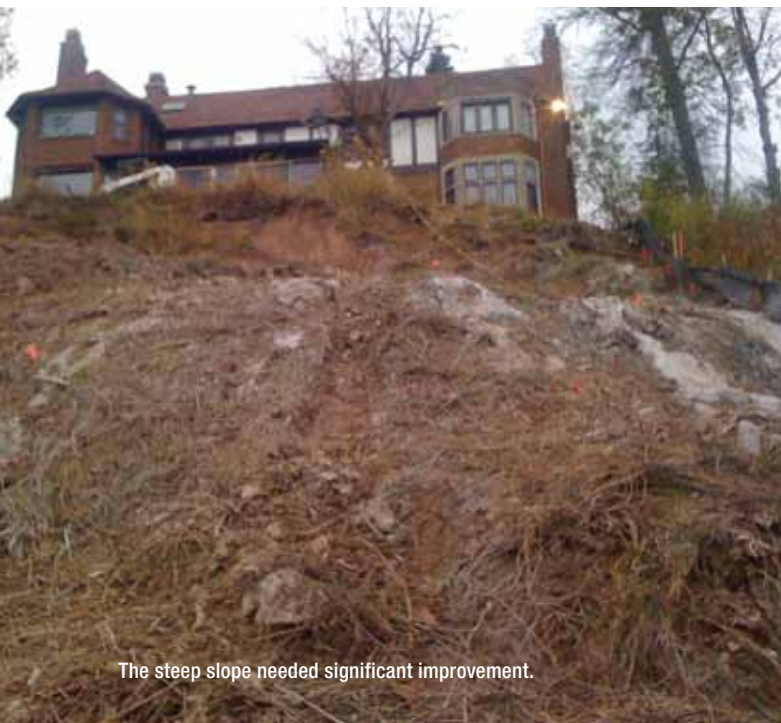
The steep slope needed significant improvement.

The new homeowners of a historic lakefront property in a suburb north of Milwaukee decided to make their newly acquired landscape a priority. Located on a 115-ft 2:1 bluff overlooking Lake Michigan, the home is positioned at the edge of the slope. While this makes for beautiful views from the porch windows, the limited access, tiny yard and steep slope required improvement.

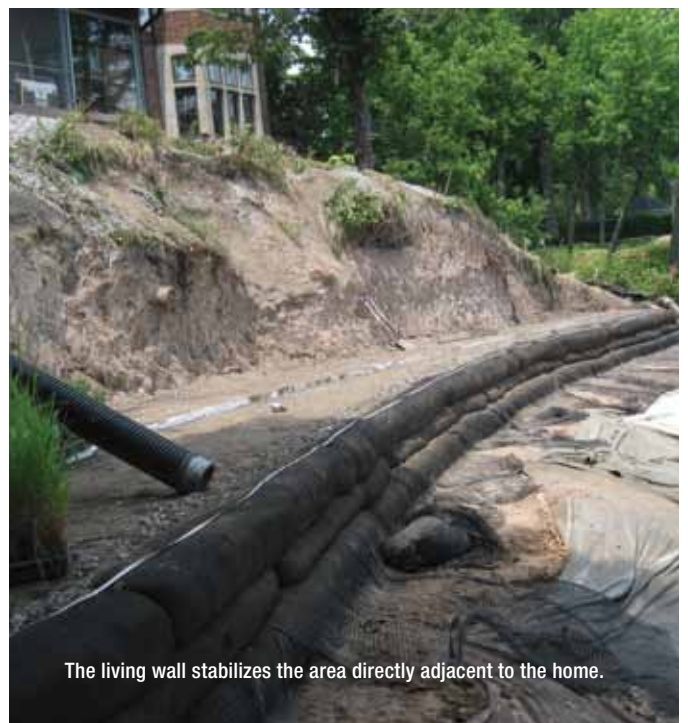
The living wall stabilizes the area directly adjacent to the home.

The living wall was selected to stabilize the area directly adjacent to the home, adding 8 ft of backyard to the upper terrace. The living wall promotes the growth of native plants, providing an appealing natural aesthetic in addition to stabilization. The team specified and designed a 100-ft long-by-15-ft high Filtrexx GreenLoxx LivingWall, consisting of lightweight geo-foam block backfill material, soil anchors and layers of geogrid wrapped around every two layers of the GroSoxx at the face of the wall. An irrigation system was integrated directly into the living wall.

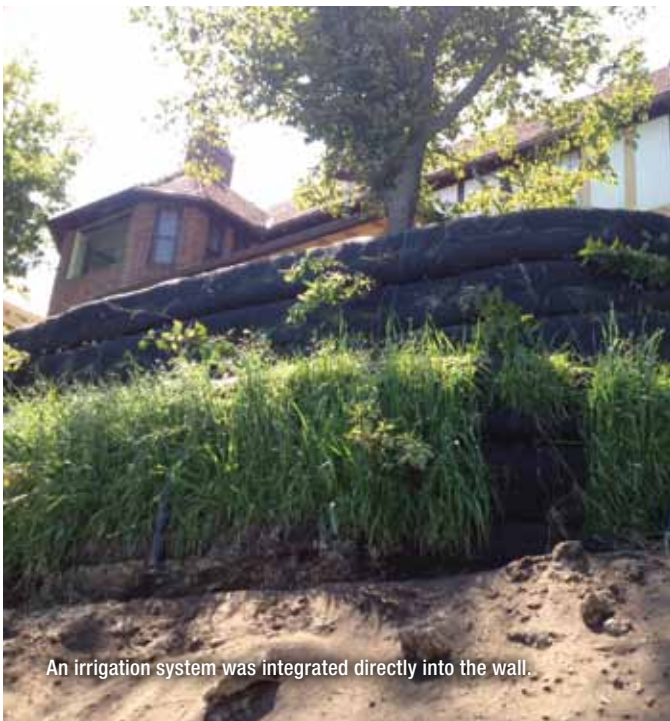
An irrigation system was integrated directly into the wall.

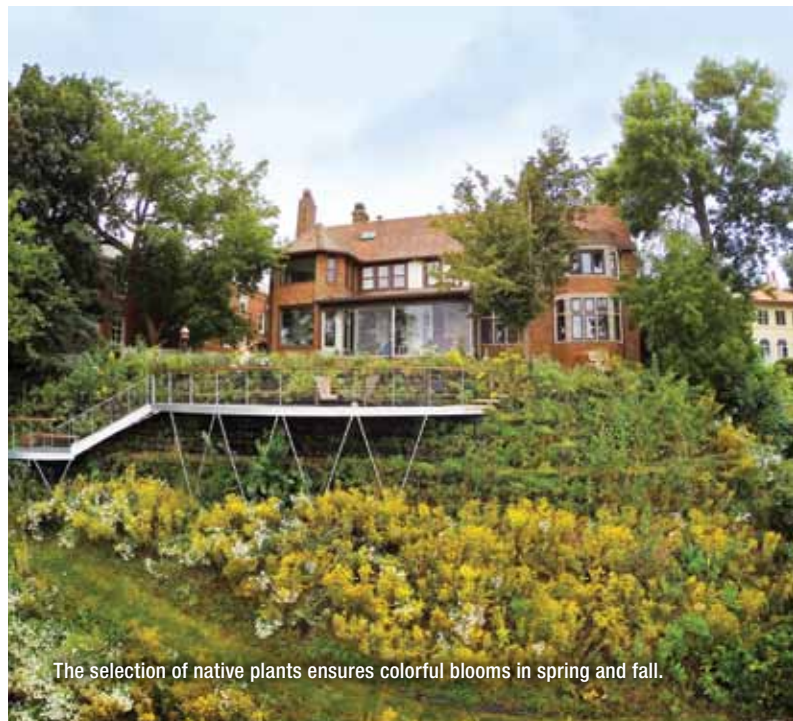
The selection of native plants ensures colorful blooms in spring and fall.

To make the surroundings of the site as natural as possible, the team specified a native plant and seed mix created for its cultural needs, aspect and stabilization

properties. More than 50 native species were incorporated into the site.

Since the project was completed in December 2012, it continues to change and grow every season. The selection of native plants ensures colorful blooms in spring, summer and fall. The project received the 2015 Wisconsin American Association of Landscape Architects Award of Merit in the Residential Category for its creative and holistic design. **SWS**
