# PROTECTING POCKET LANE

## Varied detention system mitigates drainage problems for Florida roadway

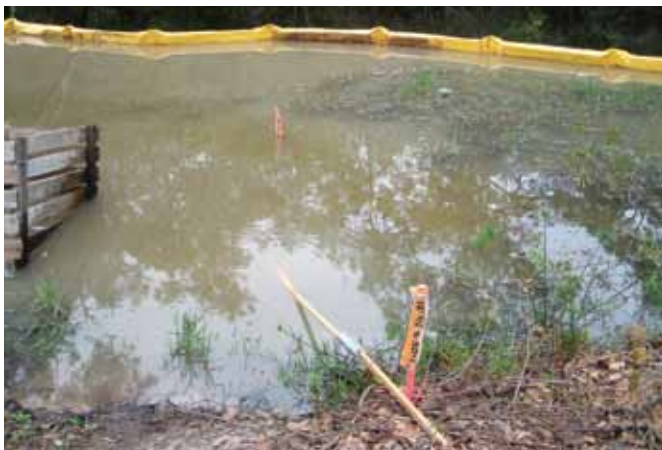
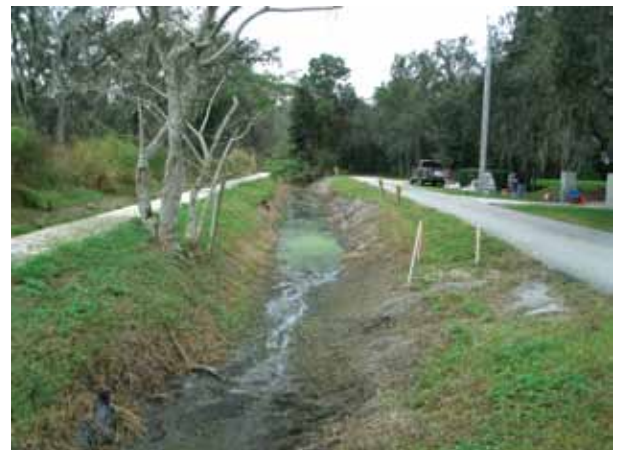
The underdrain/exfiltration system (right) functions as a wet detention pond and provides modest water quality pretreatment for the contributing basin area prior to discharge to the receiving canal system.

This alternative involves improving the existing drainage outflow from the drainage basin, which currently occurs through overland flow to the existing canal system by providing a combined underdrain/exfiltration system to replace the existing drainage ditches and discharge to the existing canal located at the south terminus of the Pocket Lane right-of-way. The system is composed of perforated pipe enveloped in gravel beds that are wrapped in geotextile filter fabric.

storage capacity will be discharged over an outfall structure located at the south end of the system and conveyed by 218 ft of 36-in. pipe to the existing canal located at the south terminus of the Pocket Lane right-of-way. The outfall structure will include a 2.75-in. circular bleed-down orifice set at the seasonal high water table elevation of 99 ft, and a 6-ft-wide outflow weir set at an elevation of 100 ft.

In addition to providing conveyance of runoff and discharge to the receiving canal system, the underdrain/exfiltration system will function as a wet detention pond and provide modest water pretreatment for the contributing basin area prior to discharge to the receiving canal system. Proposed swales will be located above the combined underdrain/exfiltration system and will be used to collect runoff from the contributing drainage areas and provide retention with infiltration for water treatment for these areas prior to overflow via raised and grated inlets into the proposed combined underdrain/exfiltration system beneath the swales and eventually outflow to the receiving system.
