# MUSSELING THROUGH

North Carolina highway project moves forward despite regulations, rain & endangered species

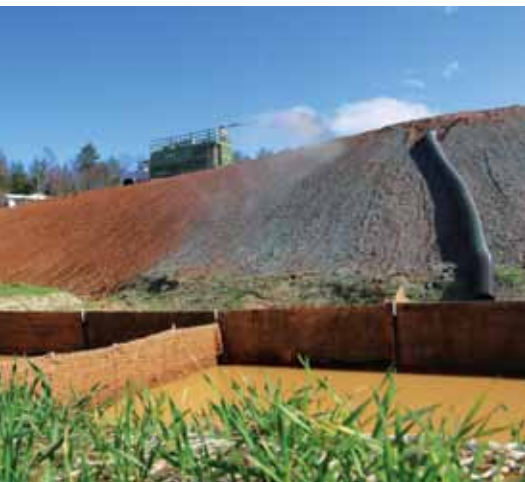
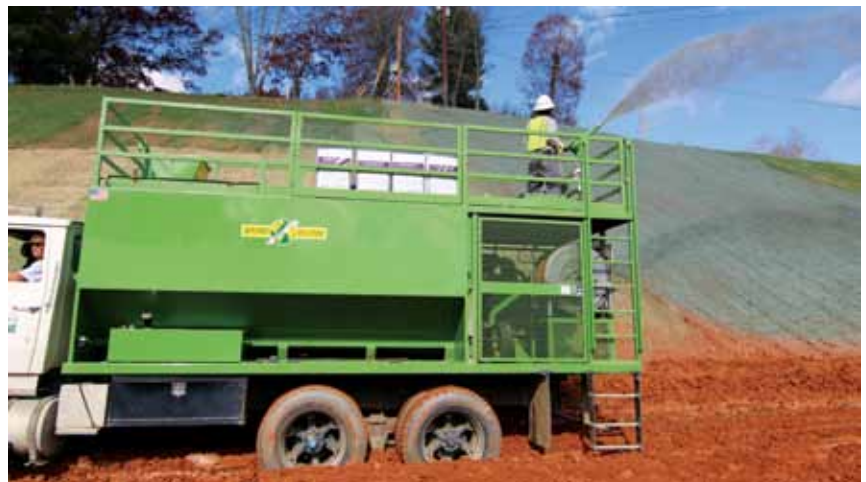
The hydromulcher allows the crew to spray up to 2 tons of limestone, 500 lb of fertilizer, 150 lb of grass seed mix and 400 lb of mulch in one application.

Stewart was able to juggle all of these requirements—the quick coverage timeline, the specific seed types and the limestone—with an Imperial 3000 hydromulcher. In one application, his crews can spray up to 2 tons of limestone, 500 lb of fertilizer, 150 lb of grass seed mix and 400 lb of mulch. The mulch is used as a tracer, to see what has been covered and what

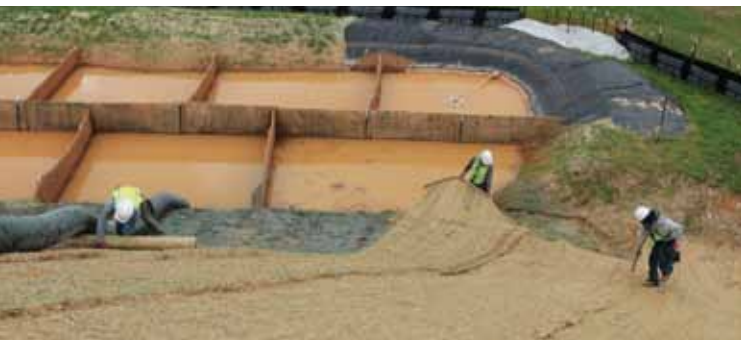
Double-net straw matting is used on almost all NCDOT projects.

NCDOT has a number of regulatory procedures to protect watersheds, including approving the specific type of temporary and permanent seed used. Stewart used a Bowie hydromulcher to apply Conwed Fibers 2000 pure wood mulch, as well as double-net straw matting, which Stewart said is used on almost all NCDOT jobs.
