Excavation & Engineering

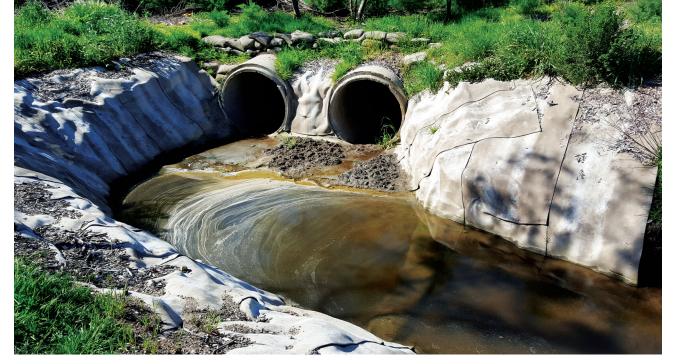
After the carrying capacity of the double-barreled culvert system was restored, GCCM was applied to prevent erosion of the exposed, non-vegetated bank at its output.

Otte, Sjoquist and an another team member retrofitted the entire siteapproximately 1,200 sq ft-in less than six hours using one bulk roll of the material. Strips of GCCM were cut to appropriate length using box cutters, laid out in a fan pattern and secured to the bank using simple decking screws. After hydrating the material, native California blackberry, arroyo willow and other wetland species were planted around the top of the bank to enhance aesthetics without impacting structural integrity.
