Chesapeake Seals the Deal

Pipe Sealing Project Prevents Future Flooding, Cave-ins

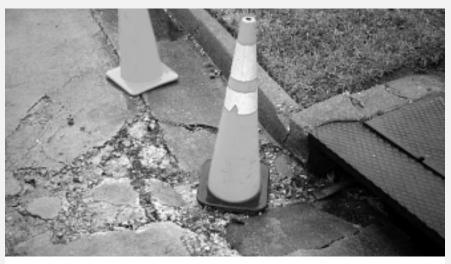
When notified of a cave-in, the City of Chesapeake responds quickly to eliminate any potential hazard.

When notified of a cave-in, the City responds quickly to eliminate any potential hazard to the public by filling the depression caused by the cave-in with crusher run material and placing traffic cones around the area, if warranted. When the permanent repair is initiated, a television camera is run through the line to assess the damage and any possible safety hazards. The line is then cleaned, utilities marked and the cave-in excavated. The damaged structure or pipe is repaired or replaced, joints wrapped with
