Corrugated PE pipe reduces flooding risks at new athletic field complex

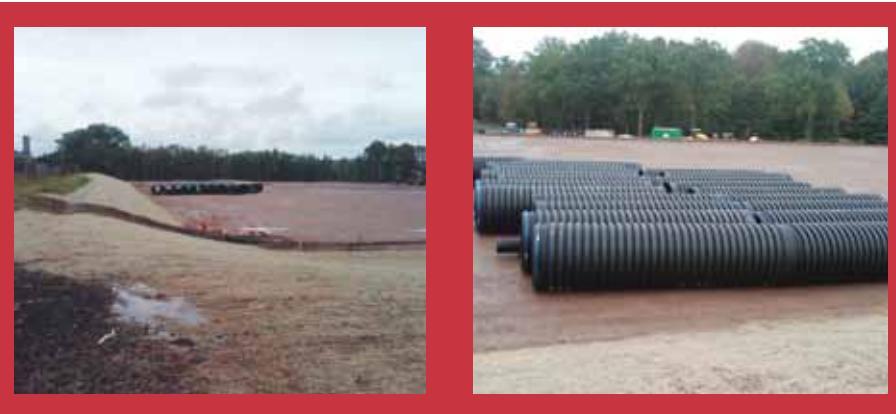
Left: The ground of the athletic field was still damp when work began, meaning no heavy equipment could be used to transport pipe. Right: 60-in. perforated corrugated HDPE and manholes were installed to collect the water and convey it to a detention system.

The project team reconsidered the 48-in. perimeter plan and decided on a different design that used even larger

diameter—up to 60 in.—perforated corrugated HDPE and manholes to pick up the water and convey it to a detention system.

LandTek to do its job. The ground was still wet from recent flooding when the construction took place, which meant that no heavy equipment could be used for installation. Workers needed to carry the pipe around the two-field, 10-acre complex by hand.
