WATERSHED REVAMP

Deteriorating New York watershed gets upgraded with BMPs, green infrastructure & wetlands

By Steven Gruber

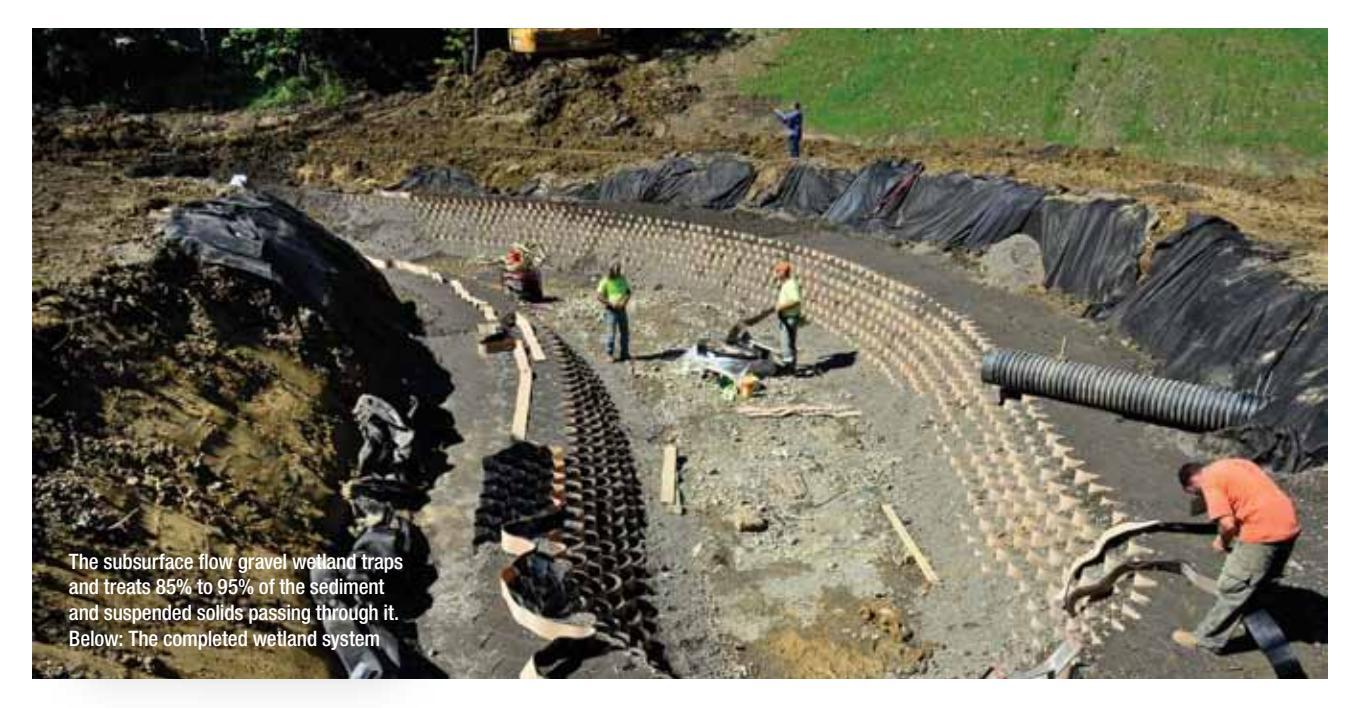
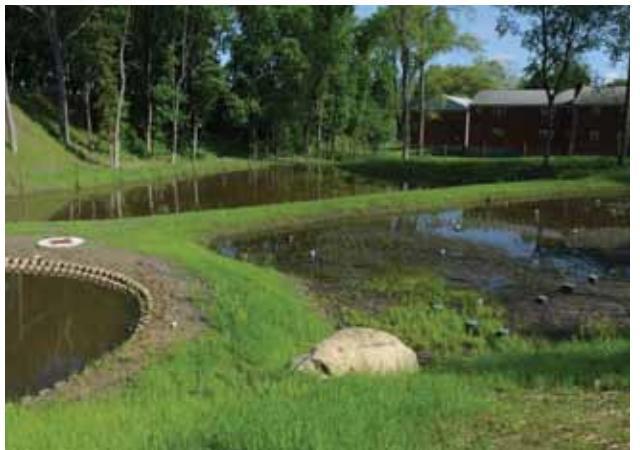
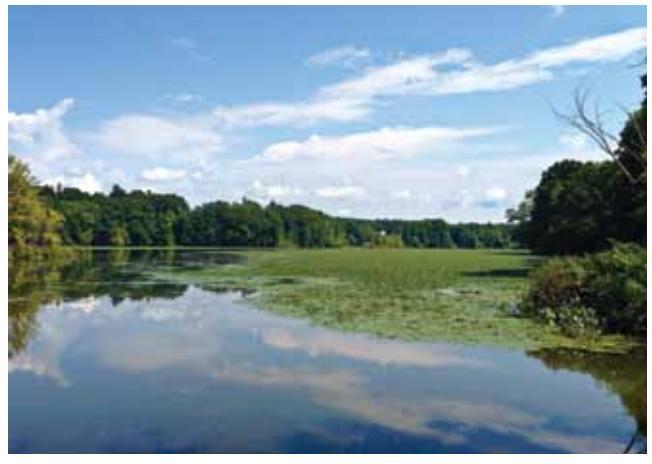
The gravel wetland filter is composed of four primary components, including a flow distribution system, layers of engineered stone and a flushing system to remove accumulated sediment. The

permanent water level is maintained just below the surface of the stone with an adjustable standpipe system. The filter's flushing system provides an opportunity to rejuvenate the wetland cell by allowing accumulated sediment to be safely flushed from matrix boxes on an impervious liner that trap the sediment below the stone media.

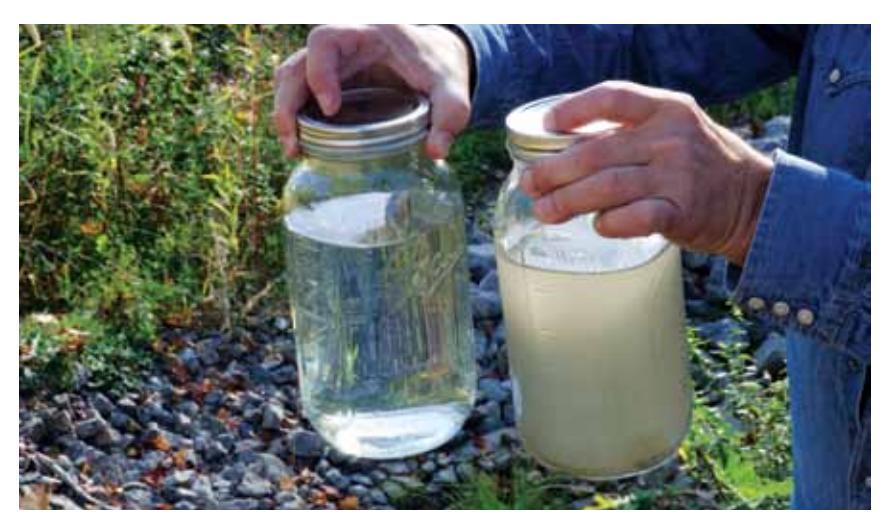
The gravel wetland filter's flushing system allows accumulated sediment to be safely flushed from matrix boxes on an impervious liner that trap the sediment below the stone media.

Air is pumped into the base of the wetland using a small compressor. While the sediment is agitated within the wetland, it is pumped out into a silt bag that captures the suspended sediment for safe disposal, and the filtered water drains back into the system, replacing what had been previously pumped out. This process is conducted twice annually. The system is routinely inspected for invasive species, signs of erosion and washout.
