[SEDIMENT REMOVAL]

Deposition **Dilemma**

Hydraulic dredging of sediment from a Pennsylvania lake

By Stephen N. Zeller & Archis Ambulkar

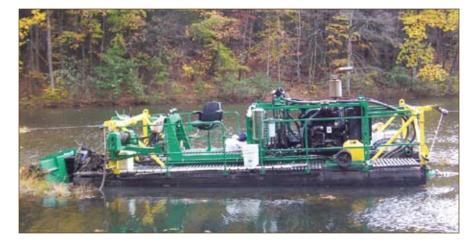
Using pumps and filter bags, workers hydraulically dredged approximately 7,000 cu yd of material from the bottom of Lake Henrietta.

About 7,000 cu yd of material from the lake bottom was dredged, primarily in the area at the upper end and around boat docks on the west side of the lake. The hydraulic dredging technique utilized a pump to lift the material deposited on the lake bottom and transfer it to large polypropylene filter bags up to 30 ft in diameter and more than 100 ft long.

The bags contained solids while water was filtered out under pressure. Within a week or two, the material in the bags generally reached a concentration comparable to wet topsoil and was moved by backhoe and dump truck. Project design placed the bags along the lake banks so that as they dewatered the drained water flowed back into the lake.
