[GEOSYNTHETICS]

A Texas golf course finds a way to augment driving range space without tearing up the grounds

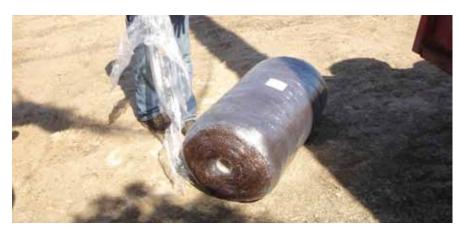
Netlon's polyethylene mesh grids provided the needed reinforcement for foot traffic and occasional parking.

The grass grows with its roots intertwined within the mesh grids to

provide a completely natural appearance while stabilizing the turf even under vehicular traffic. Kirt Phillips, golf course superintendent at Dallas Country Club, has reported that Netlon holds water well, better than areas without it. Sod establishment is ongoing, and Phillips will continue to monitor the project closely. The driving range area was used for parking on July
