borrowed TIME MANAGEMENT

Trenchless storm sewer rehabilitation on Hilton Head Island

By Cary Gaffney

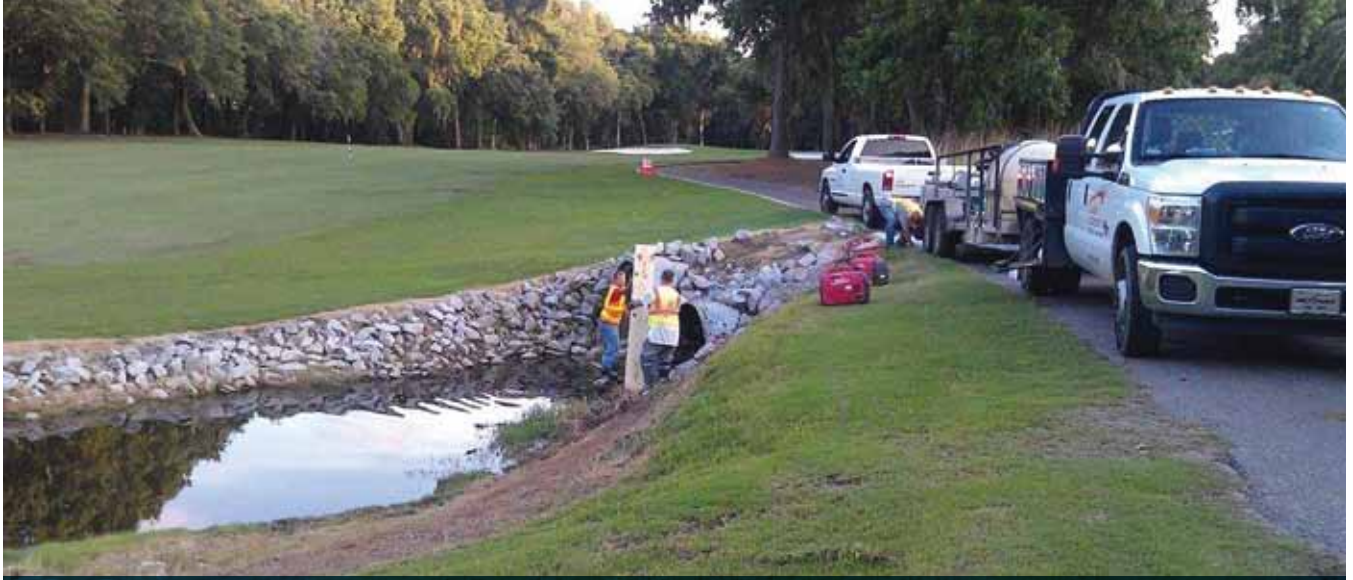
CCCP was ideal on Hilton Head Island, where minimizing interference with island traffic and keeping roads and golf courses open are priorities.
