# From Eyesore to Exquisite

New York town stops erosion and protects municipal golf course

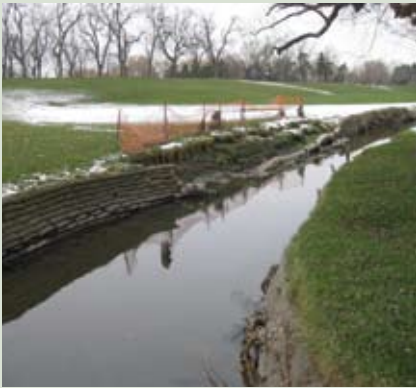
The Two Mile Creek channel originally was armored using bags of cement that hardened into walls.

“The original channel walls along the creek were built in the early 1970s out of sandbags filled with concrete, stacked on top of each other,” said Project Engineer Dan Milewski of URS Corp. “There was no drainage behind the walls at all.”

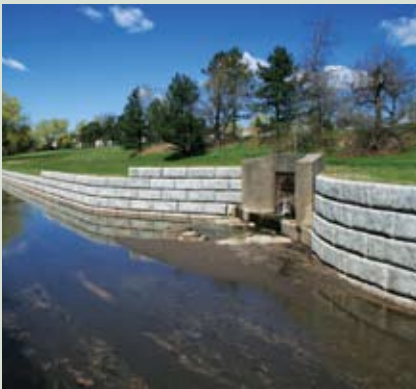
The engineer designed the channel walls to meet the creek's 100-year flood levels.

Designing the waterway to meet

the 100-year flood levels was key. The majority of the project was designed using 41-in. blocks (measured from the face of the block to the back), but engineers designed several sections of the channel using 9-in. setback blocks to give the channel walls more gradual slopes. These sections terraced back from the rest of the walls to create a secondary floodplain.

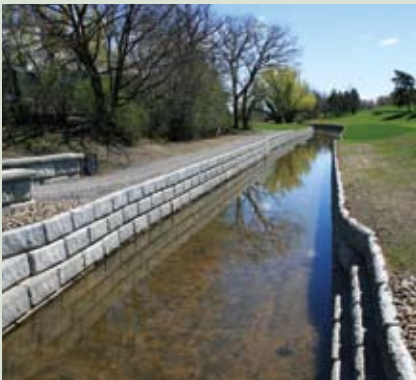
The design of the channel allowed the existing bridges to remain intact.

The town wished to keep existing bridges and abutments intact, so the project design called for using standard batter blocks to taper the channel along the inside of the abutments. To keep the volume of the channel consistent, the project team increased the depth in these areas.

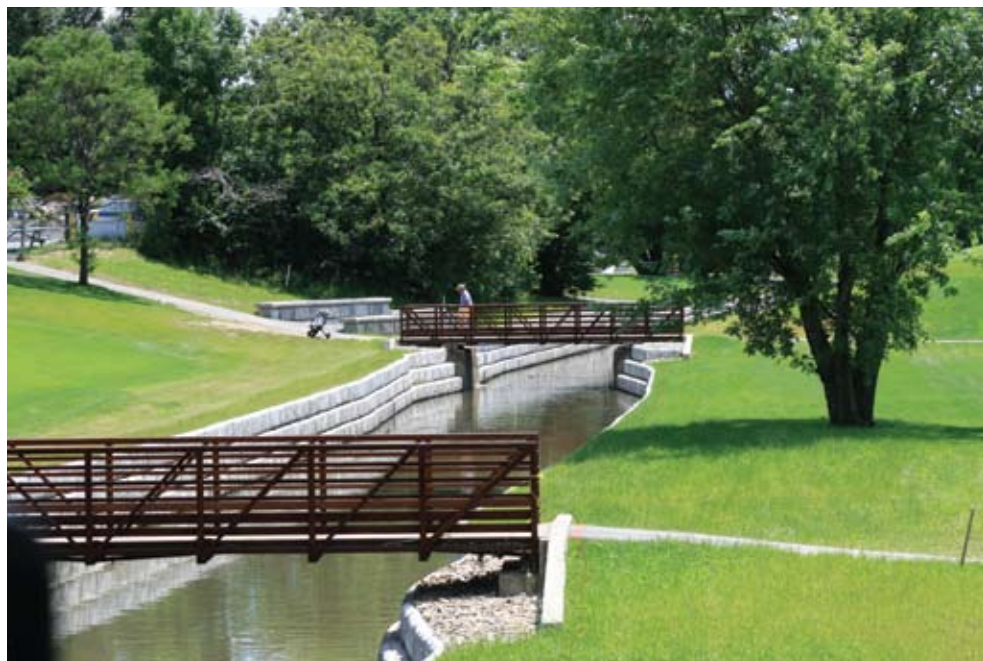
Workers installed 15,000 sq ft of channel walls on the golf course. Golfers' response to the new look has been positive.

To prepare the site for wall construction, the crew created a crushed stone leveling pad before placing the first row of 60-in. base blocks to prevent overturning of the walls.

The channel walls were built as gravity structures, which minimized excavation and installation time, helping the project meet its deadline. The entire project was installed in 60 days.
