ARMORED UP

Historic village improves flood protection

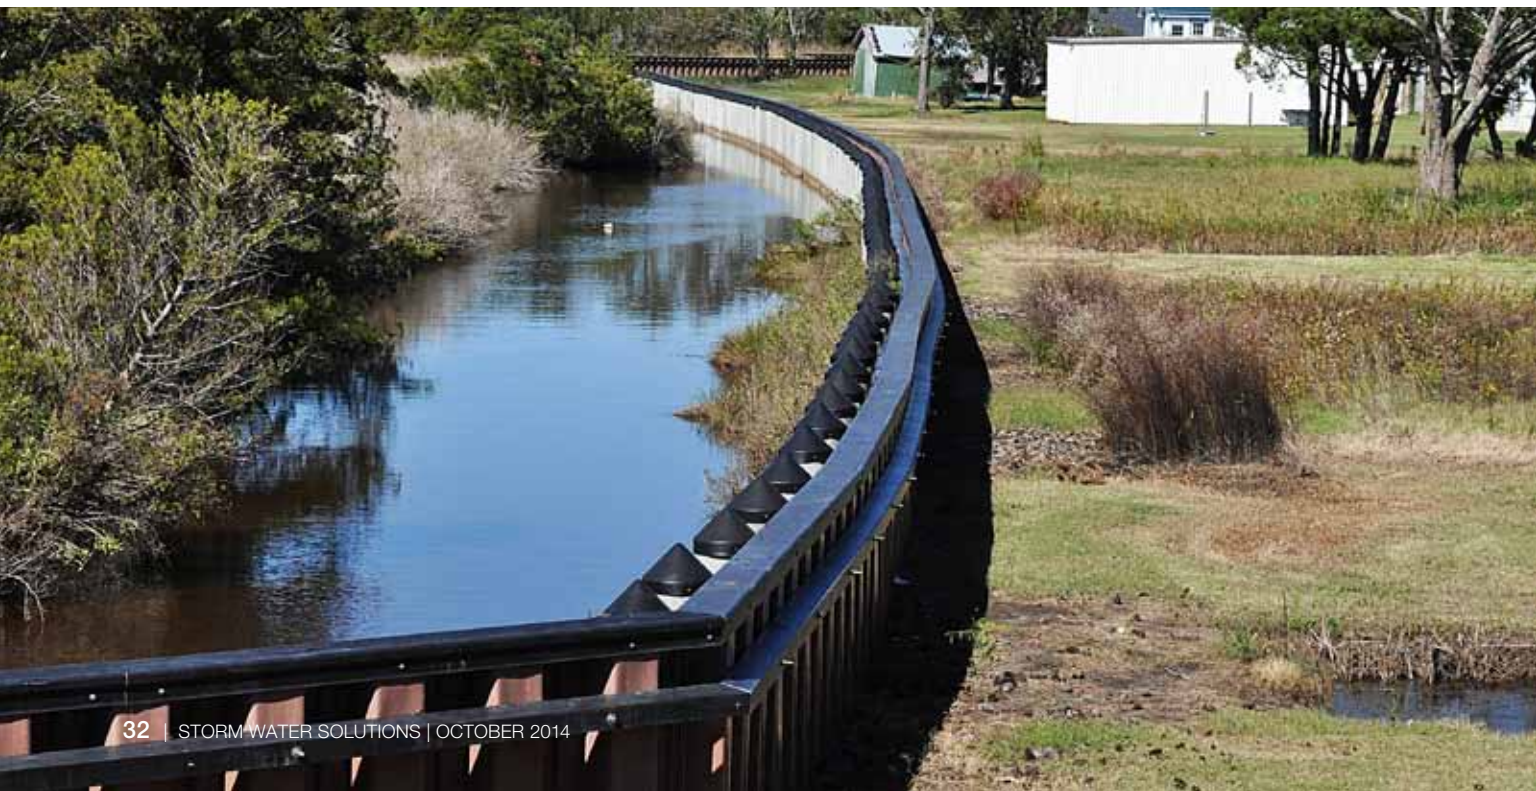
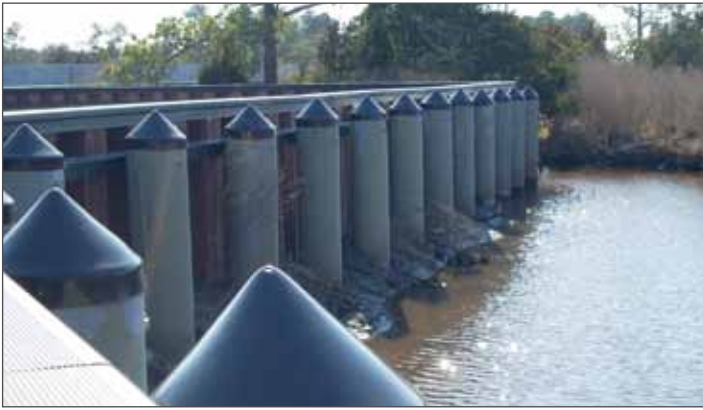
The floodwall held back rising waters from Hurricane Irene in August 2011, and damage from the hurricane was minimal.

Brown panels were selected by the community in order to best integrate into the natural surroundings. Coordinating bronze cap and wales were selected to provide additional strength and rigidity to the floodwall. For additional reinforcement, composite fiberglass pipe piles were driven every 4 ft for the entire length of the floodwall (5,936 ft).

Installation went smoothly and quickly. The team used CMI's PileClaw Mandrel to drive the 24-in.-wide sheets to 16-ft depths. The soil ranged from cohesive, heavy clays to sandy, loamy clays—and, as is common, quite a bit of buried debris. A road, owned by the North Carolina Department of Transportation,
