STAY GROUNDED

Replacing compost with a hydraulic growth medium

By Kevin Loucks

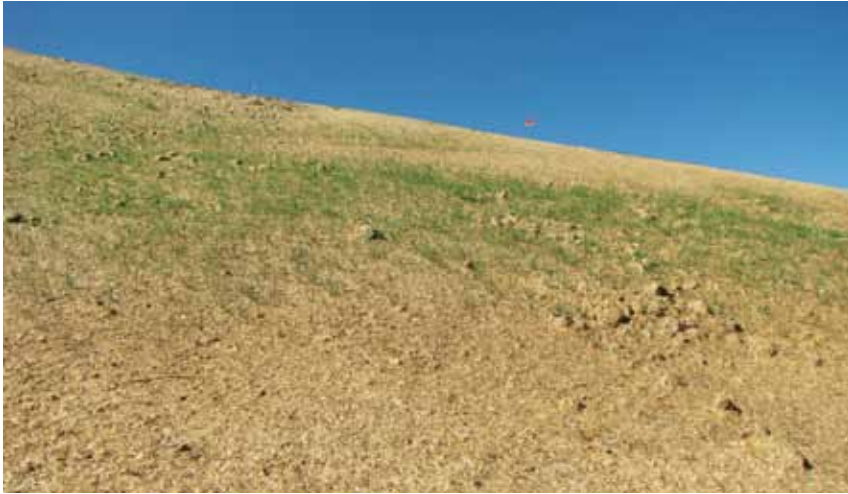
The hydraulic growth medium six weeks after planting

With all of the products performing well under aggressive erosion conditions, the focus turned to germination and plant growth. Emergence became evident within a few weeks. Although all of the treated areas showed acceptable levels of vegetation establishment after six weeks, the compost plus paper mulch (control) section had experienced severe wind shear and subsequent erosion. Wind was able to get between the mulch layer and the compost layer, separating the protective mulch layer from the loose compost.

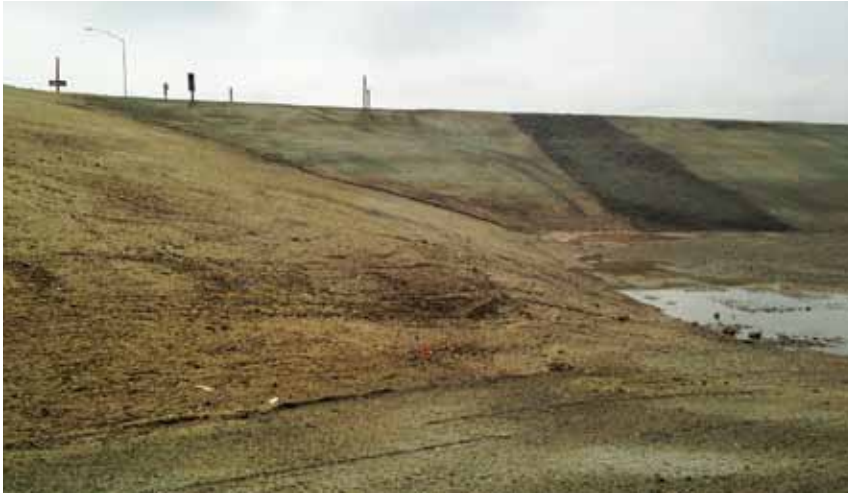
The test site after heavy rains

The first test of erosion control performance came with an unseasonably heavy rain event in late February. Approximately 3 in. of rain fell in the area over a 24-hour period, causing flash runoff in the construction area. With no diversions such as sand bags or wattles to direct water flow away from hillsides, the entire area was subjected to aggressive sheet flow from the road.

All of the test areas performed well compared with the control under these conditions. The Earth Essence Omega application on the bridge abutments also performed well. All soil remained intact.

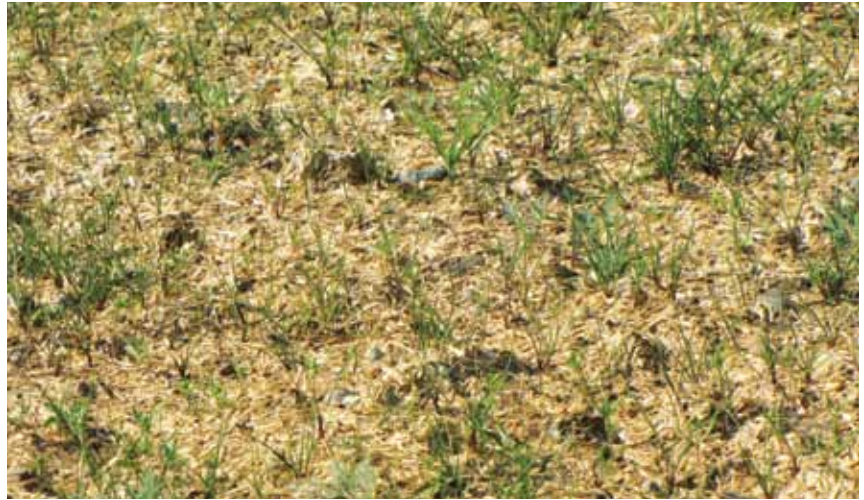
All products performed well despite aggressive erosion conditions.
