WALLED

Channel walls protect Houston neighborhood during historic floods

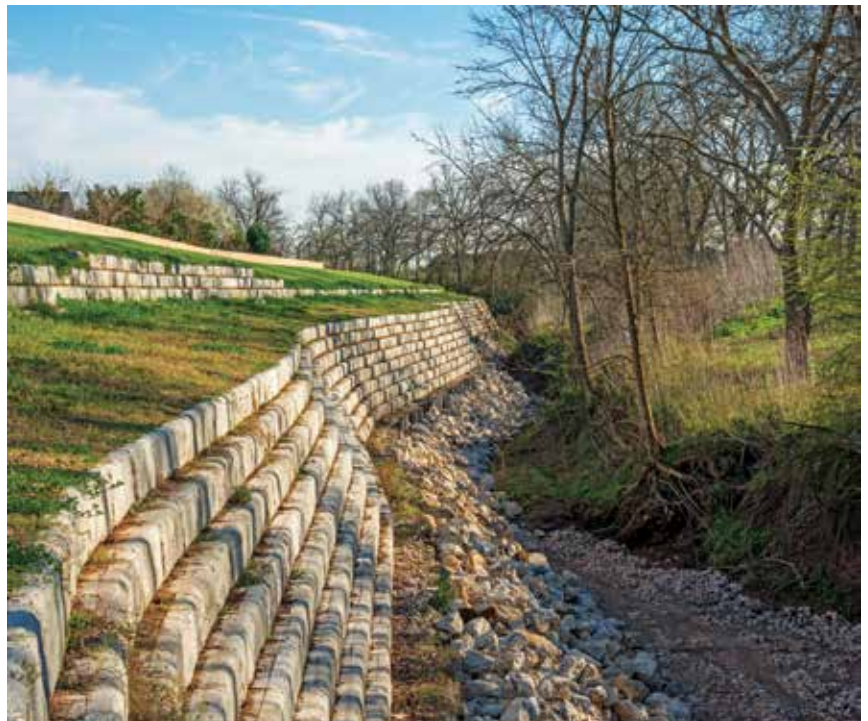
The solution includes a gravity retaining wall system coupled with a dual-level subsurface sheet piling wall for soil stabilization.

Jones|Carter specified Redi-Rock as the gravity retaining wall system for the project. The large-block retaining wall system uses 1-ton blocks that stack up, similar to Lego blocks. Gravity walls rely on the mass of each block for structural support and are used in applications like this because they can be built close to property lines.

Kalkomey explained that designers wanted to avoid having water passing through the walls and underneath the homes as water rises in the channel, because that could lead to material washing out from underneath the homes. A sheet pile cutoff wall was designed to increase overall global stability. The sheet pile wall stands 20 ft tall.

38,525 sq ft of retaining walls. The lower wall stands 13.5 ft tall and the upper wall stands up to 6 ft tall. The 9-in. setback walls give the channel a trapezoidal shape, which creates an efficient hydraulic radius for improved open channel flow rates.
