# DRIVING DEVELOPMENT

South Carolina car dealership prepares for severe storms By Frank W. Hahne

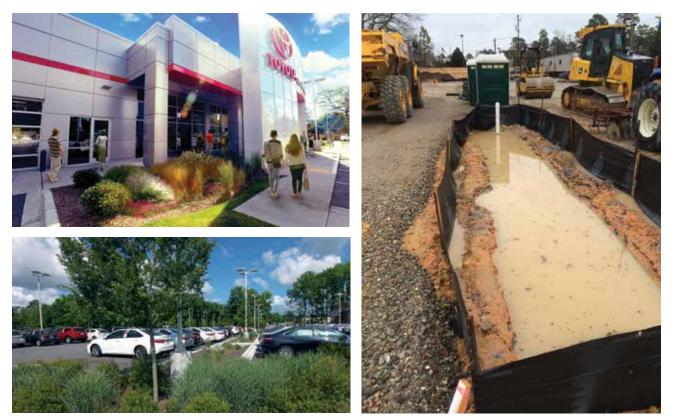
Top left: A rendering of a typical bioretention cell at maturity. Bottom left: The finished basins include crosswalks for customers and salespeople. Right: A bioretention basin built out of the recommended sequence. The basins built out of sequence had to be rebuilt due to sediment contamination.

Crosswalks were included within the bioretention cells in the parking lot so salespeople and buyers can cross them, and 6-in. pipes through the crosswalks allow the bioretention cells to act as one. All bioretention cells were landscaped with native grasses and plants to provide a year-round attractive feature.

When the site contractor constructed some bioretention basins out of the recommended sequence, they had to be rebuilt due to contamination with sediment. It is critical the bioretention basins be constructed only when the contributing area has been stabilized or paved. This can be done in the final stages of construction, during which time the site landscaping and bioretention plantings are installed.
